Tuvalu Ship to Shore Transport Project

Engineering Analysis

March 2006

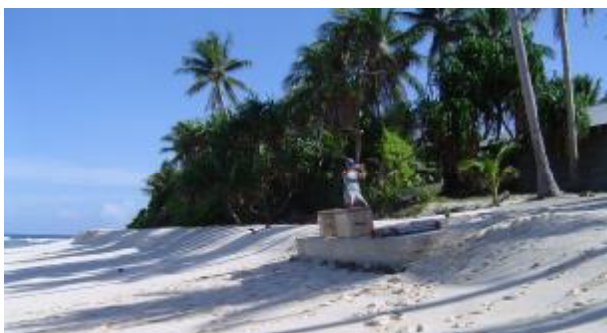
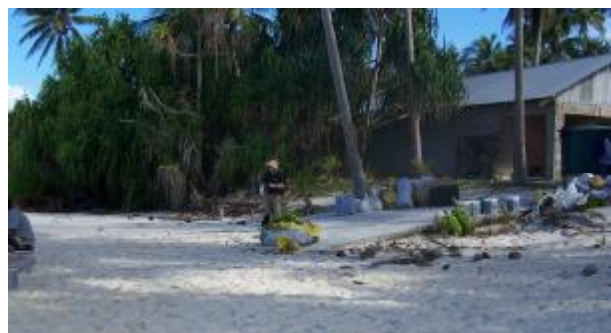
It was evident that the beach at the ramp had accreted considerably since the visit by the Review Team in late July 2003 (refer Figure 5-3 for comparison, these photos were taken looking westward). This is likely reflecting the seasonal nature of the longshore sediment transport regime on the foreshores of Niulakita. At the time of the inspection by the Pre-design Team, the upper beach at the very western end of the island had eroded quite noticeably, suggesting that this area had been the source of the sand which has accumulated in the vicinity of the landing site. The build-up and depletion of the beach at the ramp is expected to be a seasonal cycle.

Beach Ramp – 29 July 2003

Beach Ramp – 10 March 2006
